Manhole Inspection Summary

Manhole # S47CC_040MH

Insp Date: 7/31/08 9:59 AM

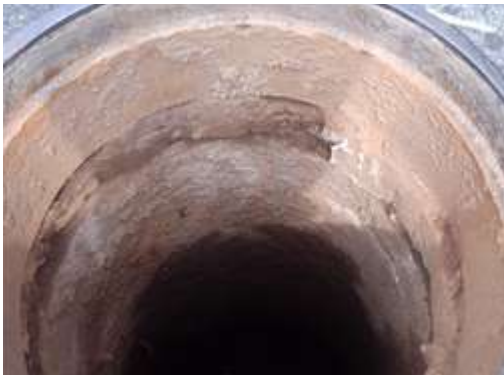
Defect 2

Offset: **1** (in.)

☒ **Leaks**

frame leaks

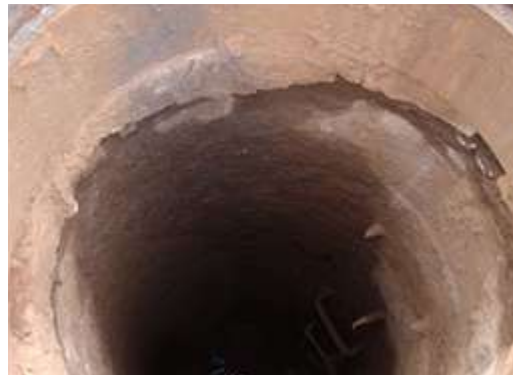
Defect 1

Infiltration: ☐ None ☐ Joint ☐ Cracks ☒ **Mortar** ☐ Roots ☐ Wall

Infiltration: ☐ None ☐ Joint ☐ Cracks ☐ Mortar ☐ Roots ☒ **Wall**

Count: **7** Missing: **2** ☒ **Corroded**

infiltration, missing steps

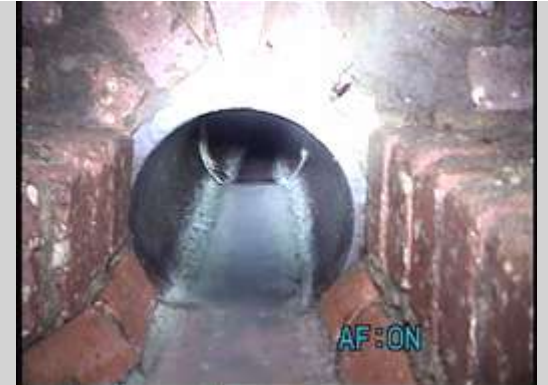
12 O'Clock Outflow

8 in. Circular Gravity Sewer
Pipe Out @ 12 O'Clock

Pipe Height: **8.4** (in.) Rod and Bar (Angled)
Pipe Material: **Clay** ☐ Pipe Lined
Invert Depth: **13.15** (ft.) Flow Characteristics: **Slow**
Deposits: ☒ None ☐ Mud ☐ Sludge ☐ Debris ☐ Grease
Silt Depth: (in.) Deposits Extent:
Infiltration: **None** Pipe Seal Cond: **Sound**

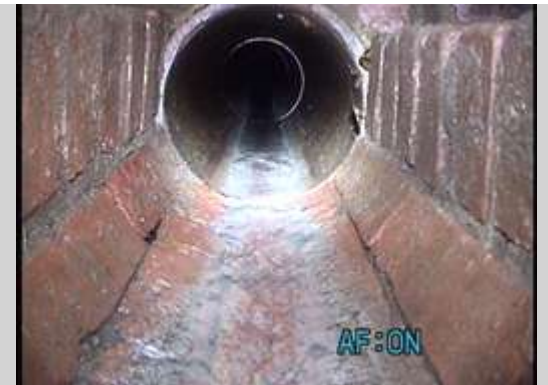
6 O'Clock Inflow

8 in. Circular Gravity Sewer
Pipe In @ 6 O'Clock

Pipe Height: **8.4** (in.) Rod and Bar (Angled)
Pipe Material: **Clay** ☐ Pipe Lined
Invert Depth: **13.05** (ft.) Flow Characteristics: **Slow**
Deposits: ☒ None ☐ Mud ☐ Sludge ☐ Debris ☐ Grease
Silt Depth: (in.) Deposits Extent:
Infiltration: **None** Pipe Seal Cond: **Sound**

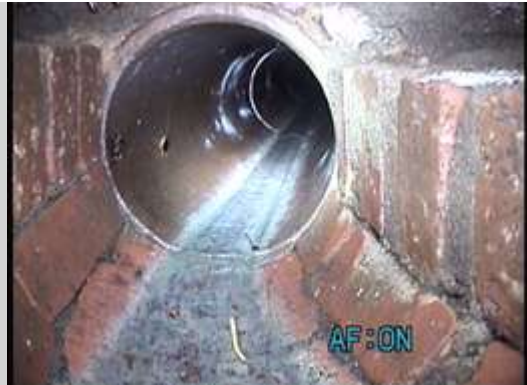
9 O'Clock Inflow

8 in. Circular Gravity Sewer

Pipe In @ 9 O'Clock

Pipe Height: **8.4** (in.) Rod and Bar (Angled)

Infiltration: **None** Pipe Seal Cond: **Sound**
